CASE STUDY

Yale University, New Haven Connecticut, USA

Surface type: Marble

Product: **HANAFINN Oxy-**

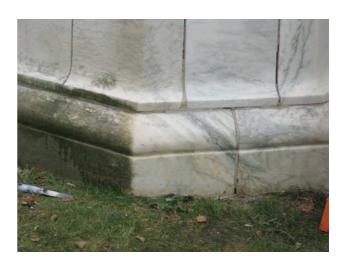
The featured marble structure marks only one of many interesting and unique societies that run under the Yale umbrella. Having withstood the test of time, the structure had accumulated stains from moss and mildew growth, as well as grime and other residues affected by Connecticut's generally cooler climate.

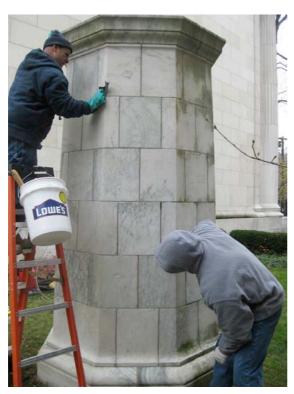
The result speaks for itself. Fig. above shows 3 sides of the structure - the far right side and the other 2 sides pre- and post-Oxy-Klenza™ respectively. As required, the original look of the structure was retained.

First, the structure was rinsed with plain water. Then some Oxy-Klenza[™] was mixed with water into a paste, and applied with brushes. Dwell time is especially important to allow any cleaner to adequately break down dirt and stains, so Oxy-Klenza[™] was a huge advantage as a paste could be formed of the perfect thickness to stick and work on the vertical surfaces for a full 15 minutes. The structure was then thoroughly rinsed with a portable

nozzle not held too close to the surface with softer stones to avoid pitting). A second application of Oxy-KlenzaTM paste was then applied to some areas with particularly deep soiling, allowed dwelling again for 15 minutes before a final rinse.
